State of California — The Resources Agency
DEPARTMENT OF PARKS AND RECREATION
PRIMARY RECORD

*Resource Name or #: K30

c. Address 8673 Salmon Avenue

*P3a. Description: This property includes three small residences. The unpaved lot is used as an informal trailer park. The trailers, though mainly recreational, are used as long-term residences. Some native trees survive on the lot. (continued)

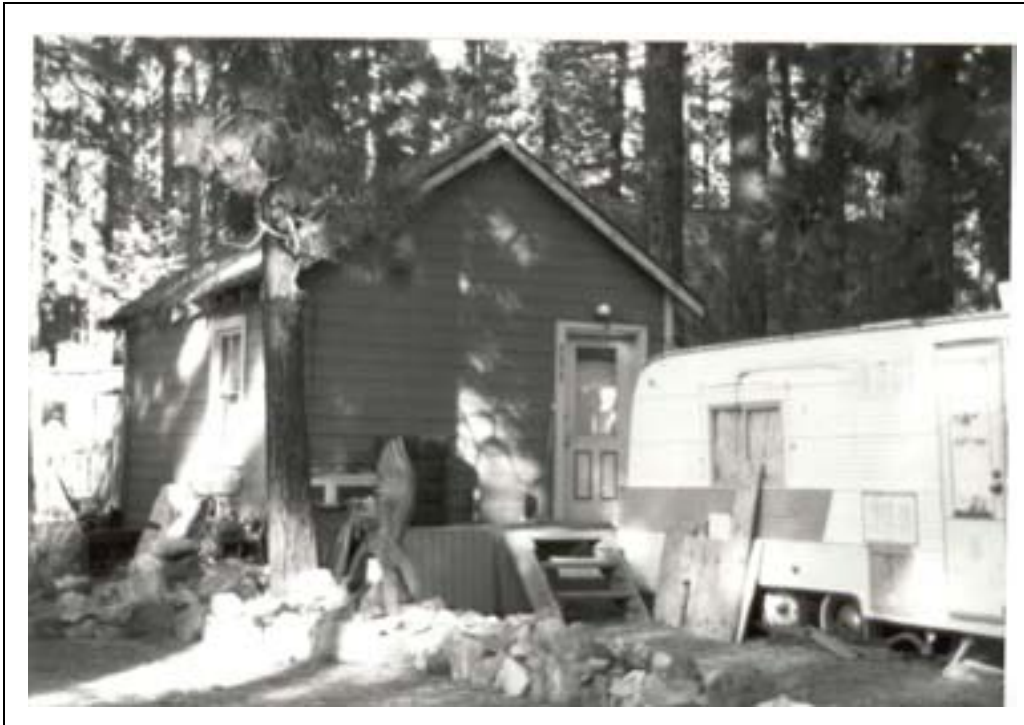
P5b. Description of Photo:
090-126-024, Building A, View NE.
Roll KBB4, Fr. 7. 11-14-02, 2:55 PM.

Building A is a one-story rectangular plan wood frame house. It has an end-gable roof with open eaves and exposed rafters. Walls are sheathed with wood V-rustic siding. Windows are wood 1/1 sash. The door is wood panel with one light. It has a small open front porch. The building appears to be unmodified.

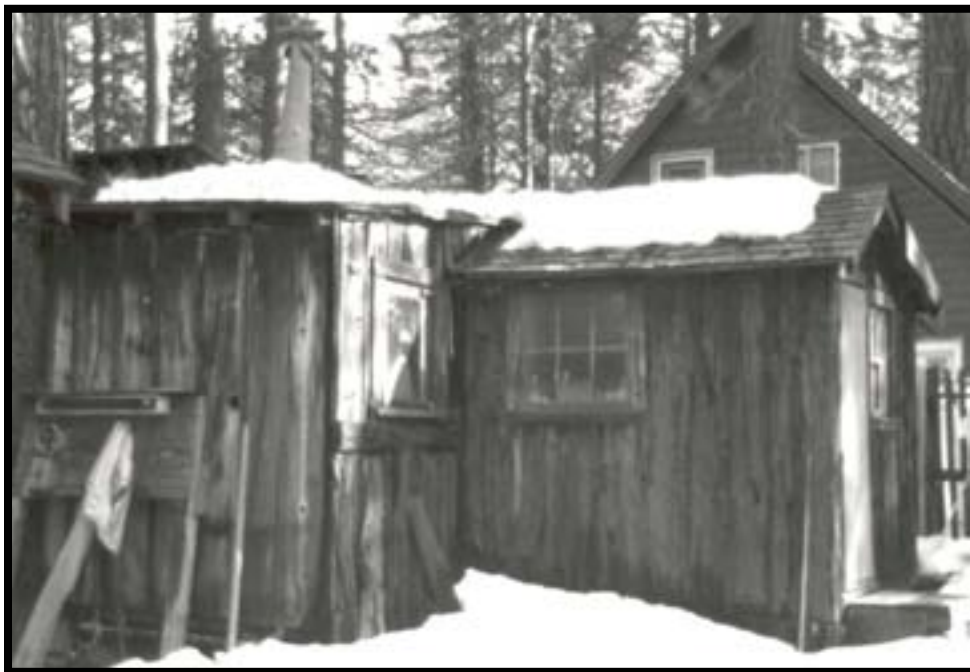
090-126-024, Building B, View NE. Roll KBB6, Fr. 26. 01-17-03, 10:28 AM.

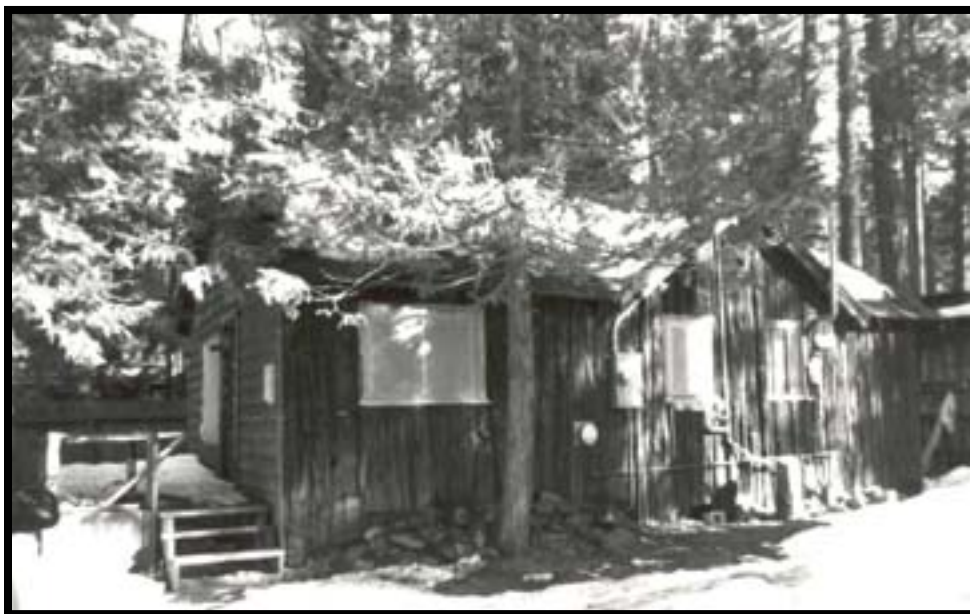
090-126-024, Building C, View NE. Roll KBB6, Fr. 27. 01-17-03, 10:29 AM.

Building C is a one-story rectangular plan wood frame house. It has an end-gable roof with exposed rafters and open eaves, clad with composition shingles. Windows are 4/1 wood double-hung and the door is clad with V-rustic siding. It has a small covered entrance porch with a shed roof. The building appears to be unmodified.

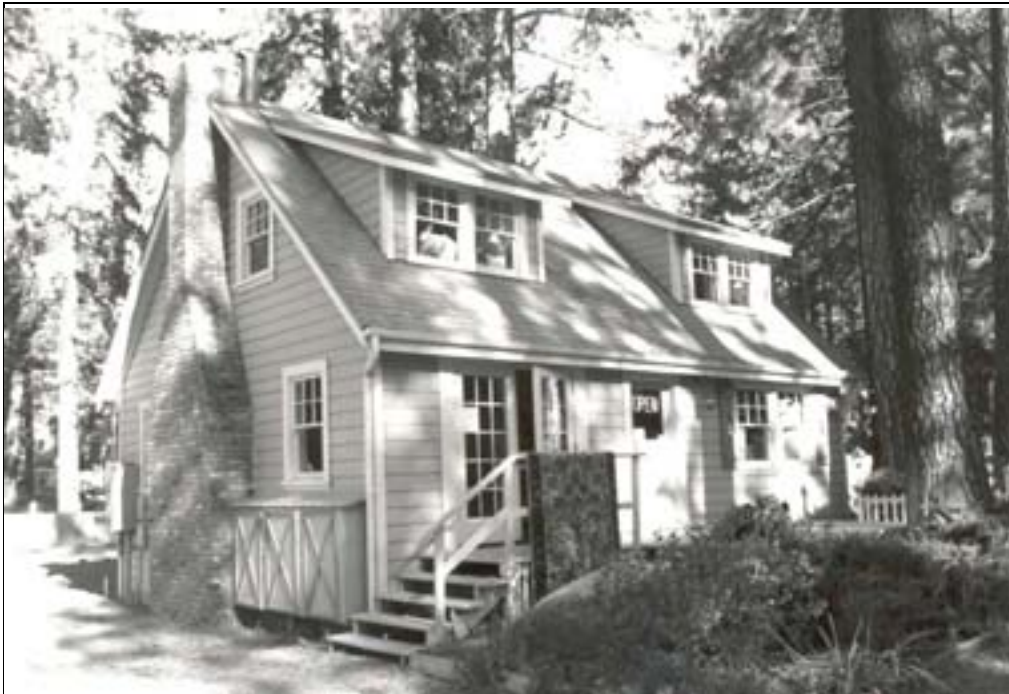
P5b. Description of Photo:
090-133-015, Building A, View NE.
Roll KBB3, Fr. 28. 11-14-02, 1:34 PM.

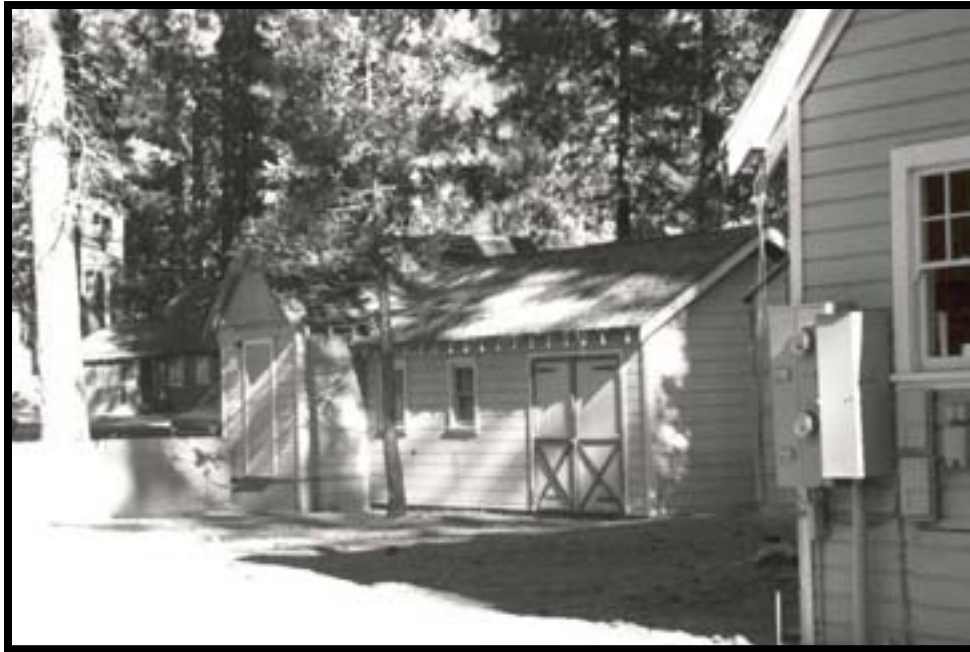
Building B is a one-story L-plan wood frame house now used for storage. It has a cross-gable roof with open eaves and exposed rafters, clad with milled wood shingles. Walls are sheathed with painted V-rustic siding. Windows are 4/2 and 1/1 wood double-hung. Doors are flush. Carriage-house doors are made of V-rustic siding. This building appears to have been made by joining two small rectangular buildings. A covered porch is on the east side of the building.

090-133-015, Building B, View NE. Roll KBB3, Fr. 29. 11-15-02, 1:36 PM.

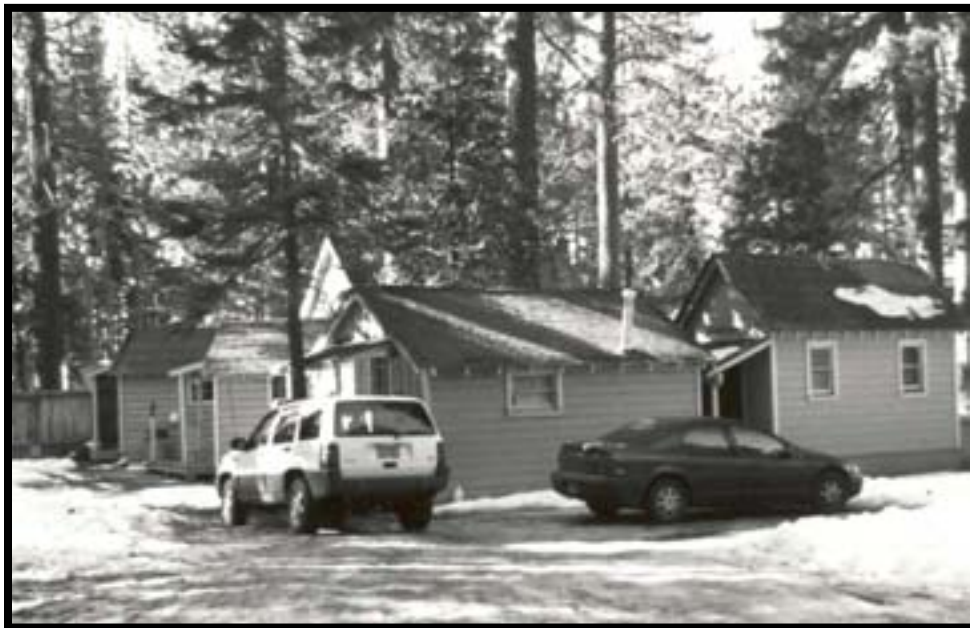
090-133-015, Rear of Building B at right, Building C to left.
Roll KBB6, Fr. 25. 01-17-03, 10:15 AM.

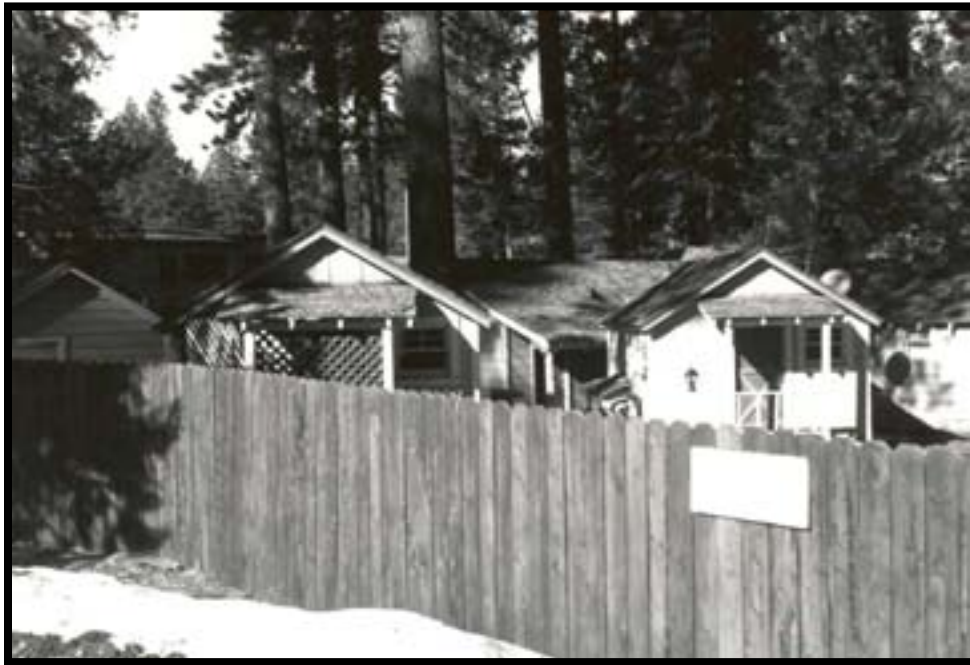
Buildings D and E are nearly identical. They are one-story rectangular plan wood frame houses. They have end-gable roofs with exposed rafters and open eaves, clad with milled wood shingles. Windows are 4/1 and 1/1 wood double-hung and wood four-light casement. Doors are clad with V-rustic siding. Each building has a small covered entrance porch with a shed roof. The buildings appear to be unmodified except for some wood lattice attached to the porch on Building E.

090-133-015, Buildings D and E, View NW.
Roll KBB6, Fr. 29. 01-17-03, 12:30 PM.

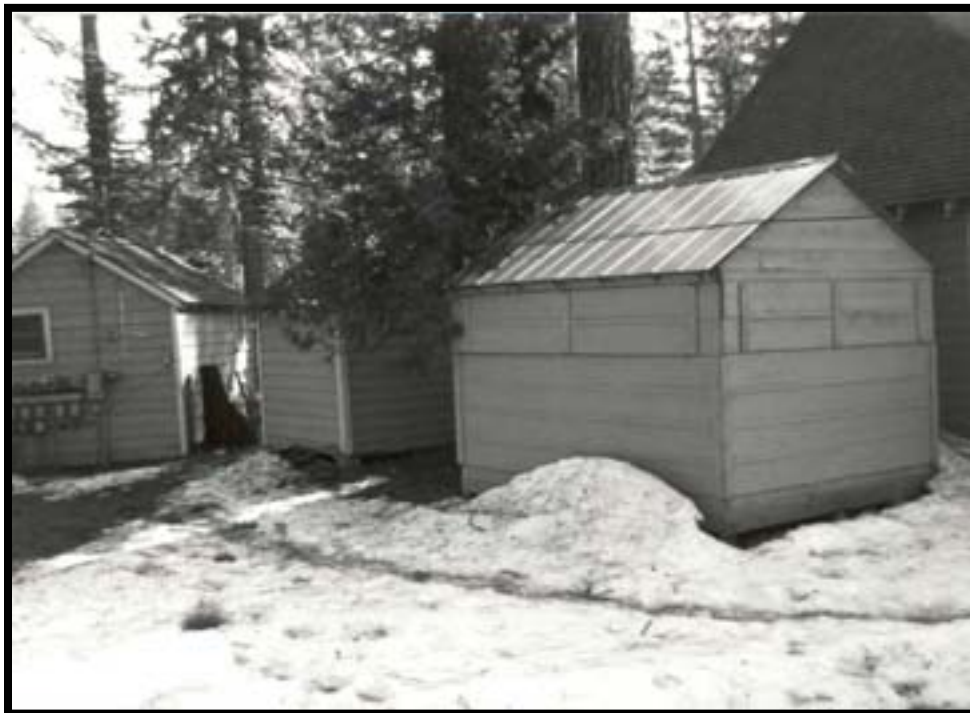
There are also two small outbuildings located immediately north of Building A. The eastern of these is a shed with a gable-roof clad with milled wood shingles. It is sheathed with wood drop rustic siding. The western of these appears to formerly have been a concession stand, since it has horizontal full-length plank shutters. It has a gable roof clad with aluminum panels. Walls are clad with horizontal board and batten siding.

090-133-015, Sheds at rear of Building A, View SE.
Roll KBB6, Fr. 30. 01-17-03, 12:35 PM.

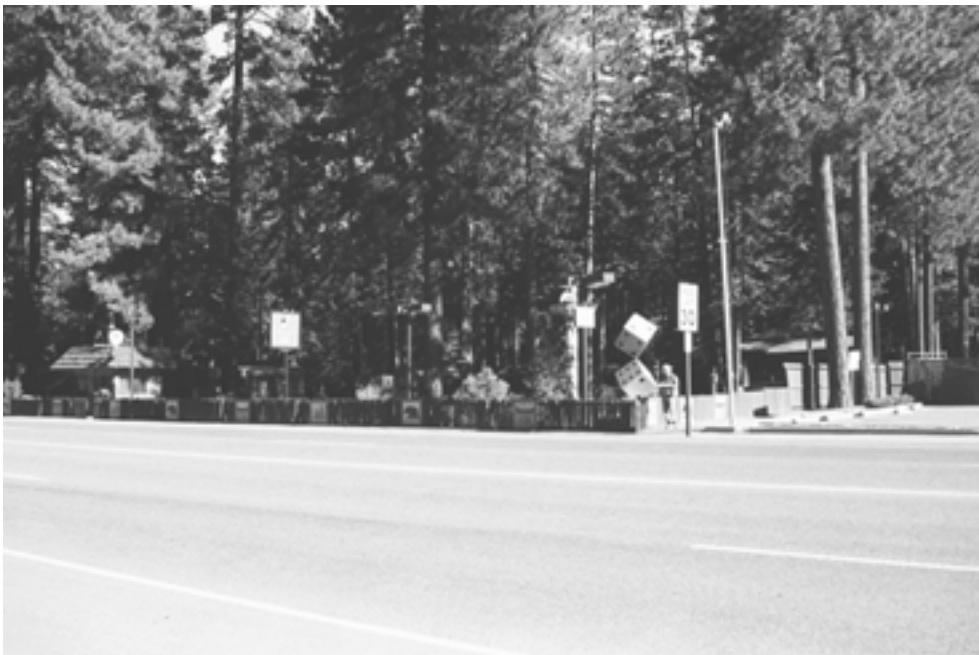
***P3a. Description:** The property is a wooded lot occupied by a meandering miniature golf course. Two small buildings are present. The restroom occupies a rectangular plan wood-frame building. It has a side-gable roof clad with composition shingles. Walls are sheathed with wood V-rustic siding. Windows are metal sliders.

Overview, view N.

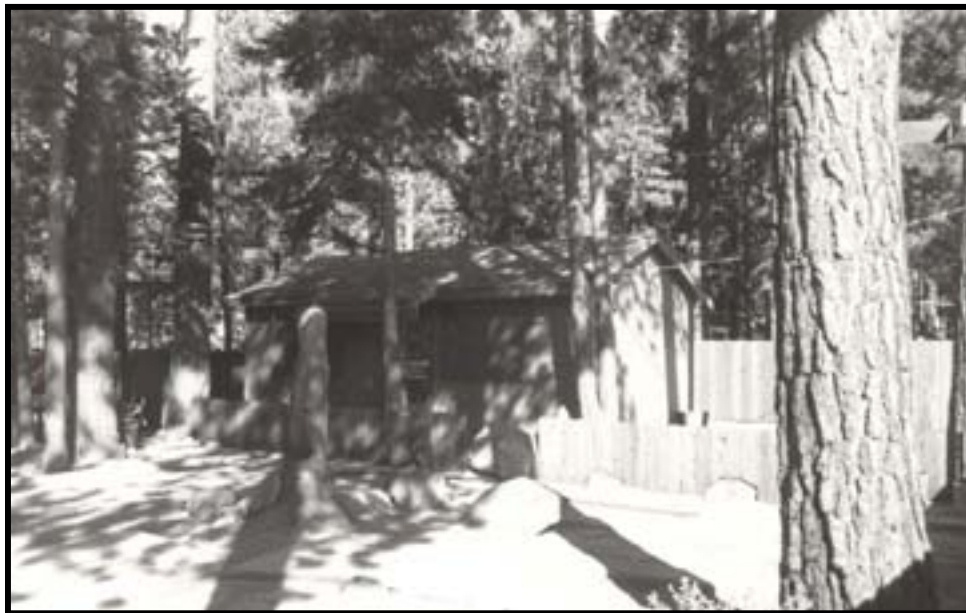
Restroom, view NNW. Roll KBB1, Fr. 11, 10-30-02, 10:25am.

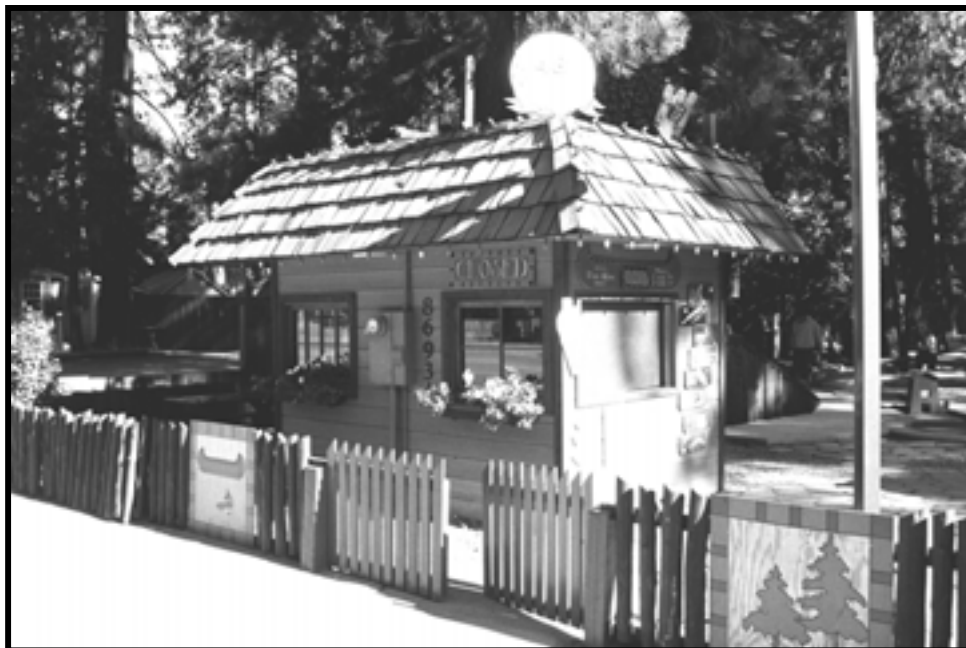
A small wood-framed entrance kiosk has a mansard roof with wood shingles. Walls are sheathed with wood V-rustic siding. Windows are fixed with wood frames.

Entry kiosk, view NNW. Roll KBB16 Fr. 2, 8-26-05, 9:10am.

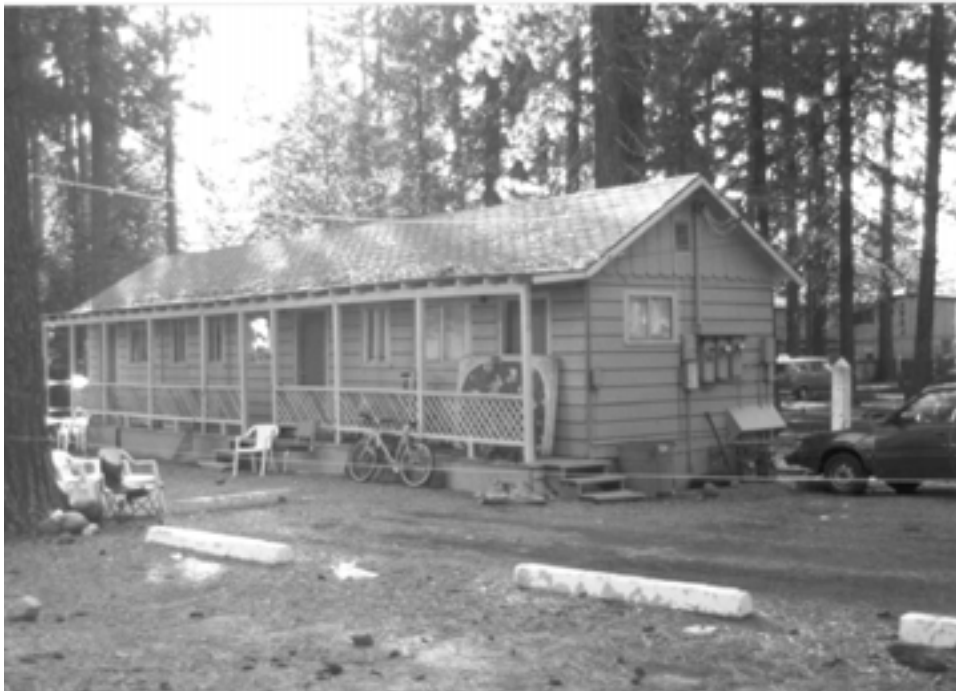
*P3a. Description: This building is a one-story rectangular plan wood frame apartment building. It has a side-gable roof with exposed rafters and open eaves, clad with composition shingles. Walls are sheathed with horizontal painted custom milled 2x8 inch drop rustic siding. Gable ends are sheathed with beaded vertical planks. Windows are metal sliders and doors are flush. A full-length shed-roof porch runs along the east side of the building. Porch pillars are simple. Recent lattice is incorporated into the porch railings and the skirting under the porch is plywood.

P5b. Description of Photo:
090-133-008, View SW.
Roll KBB4, Fr. 5 11-14-02, 2:45 PM.

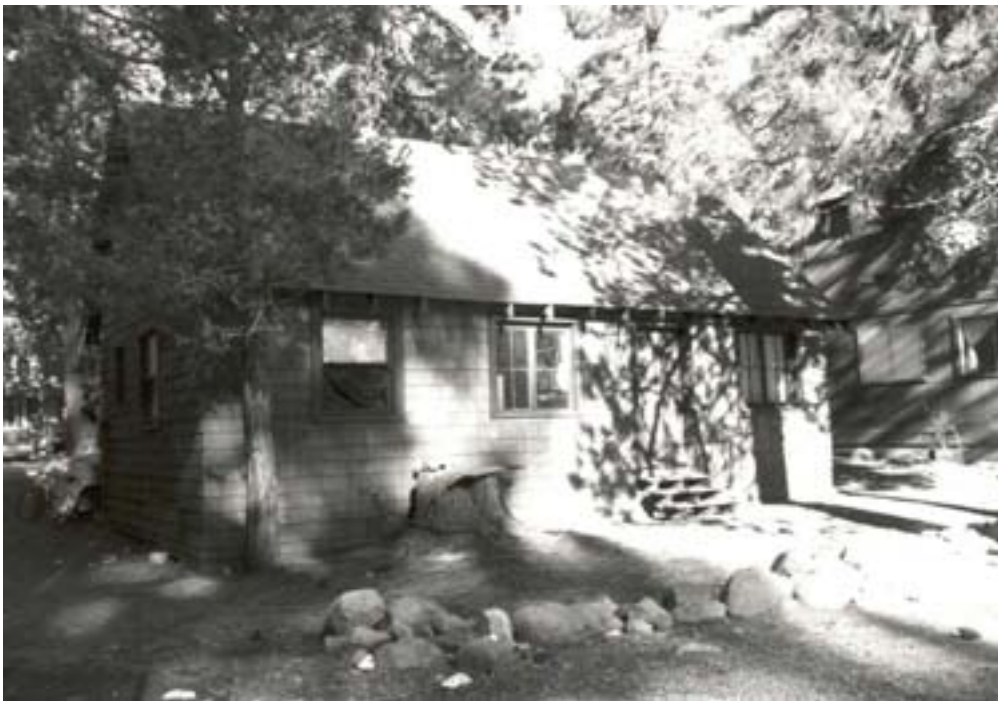
*P3a. **Description:** This building is a 1½ story rectangular plan wood frame house. It has a cross-gable roof with exposed rafters and open eaves, clad with composition shingles. Walls are sheathed with milled wood shingles and wood V-rustic siding. Windows are wood, including 1/1 double-hung and paired four light casement. The doors are sheathed in log cabin siding. A small rear addition appears to be old. Native trees are on the grounds.

090-192-003, View NE.

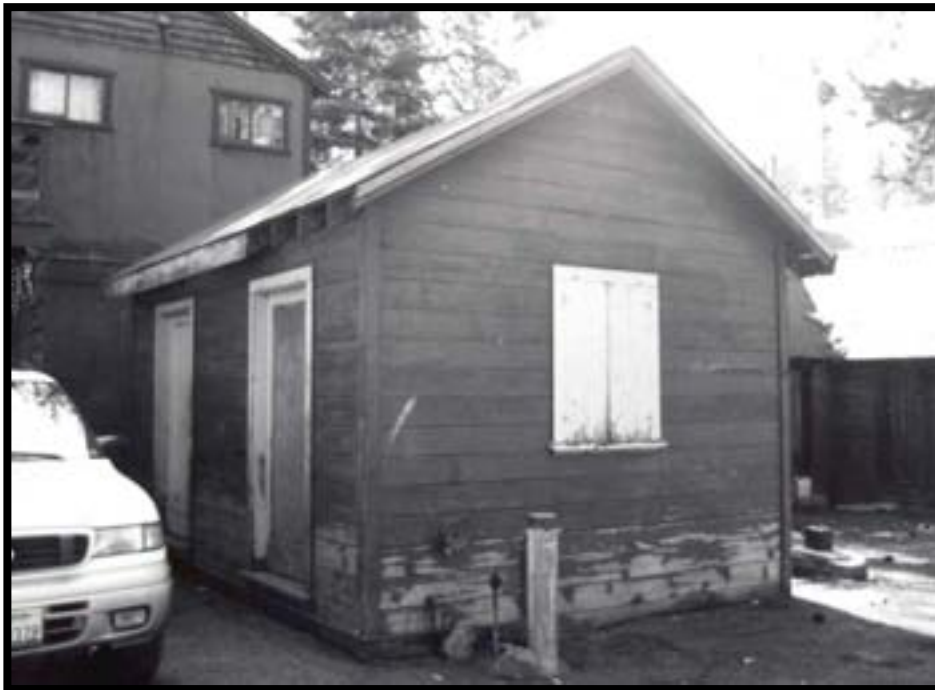
Building B is a small one-story rectangular plan wood frame outbuilding. It has a side-gable roof with open eaves and exposed rafters, except where a portion of fascia has recently been added. The roof is clad with composition shingles. Walls are sheathed with painted V-rustic wood siding. Windows are shuttered. The doors are wood panel. The building is mounted on mass-produced truncated pyramid-shaped cast concrete piers. The building has symmetrically-placed twin doors and venting suggesting former use as a restroom.

Building B; View SW. Roll KBB10,
Fr.20. 03-12-03, 1:50 PM.

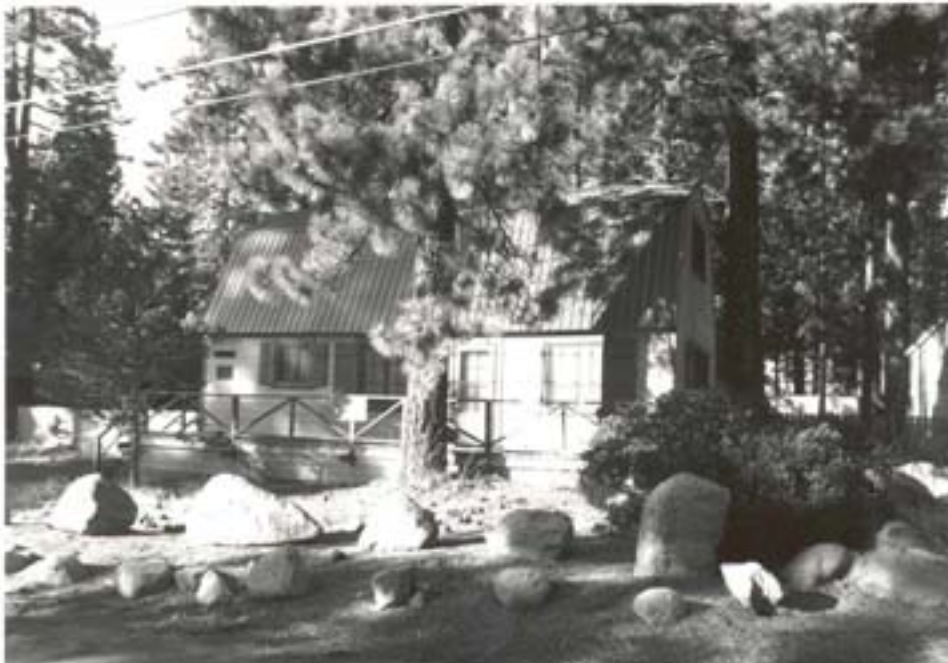
*P3a. Description: This building is a 1½ story rectangular plan wood frame house. It has a gambrel roof clad with recent standing-seam metal. Walls are covered with V-rustic siding. Windows are wood 6 and 4 light paired casement with operable shutters. The door is wood with lights, partly obscured by a recent storm door. An open porch with wood truss railing runs along the south side of the house. The yard is fairly unaltered and supports native trees.

P5b. Description of Photo:
090-191-018 View NW.
Roll KBB4, Fr.1. 11-14-02, 2:20 PM.

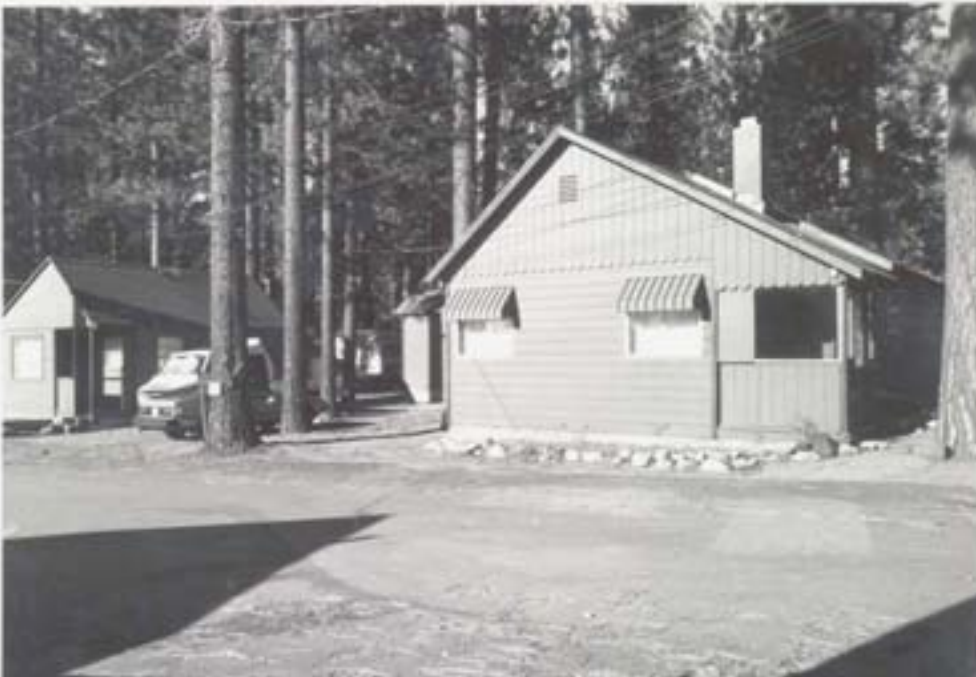
Building D is a one-story rectangular plan wood frame house. It has a gable roof with open eaves and exposed rafters, clad with composition shingles. The building has an inset corner entry porch. Walls are clad with wood V-rustic siding. Windows are wood 4/4 and 4/1 double-hung, 8 light fixed, and 12 light fixed. It has a panel door. There do not appear to be any modifications.

Overview. Building A at right, Building D at left, View NW.

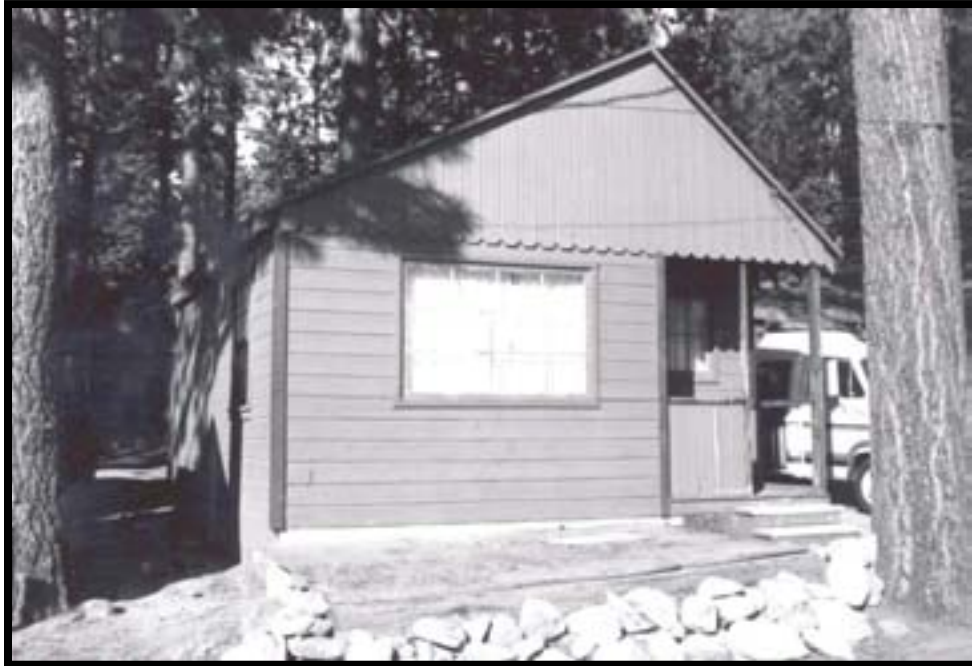
090-192-053 Building D, View NE.
Roll KBB10, Fr.22. 03-12-03, 3:41 PM.

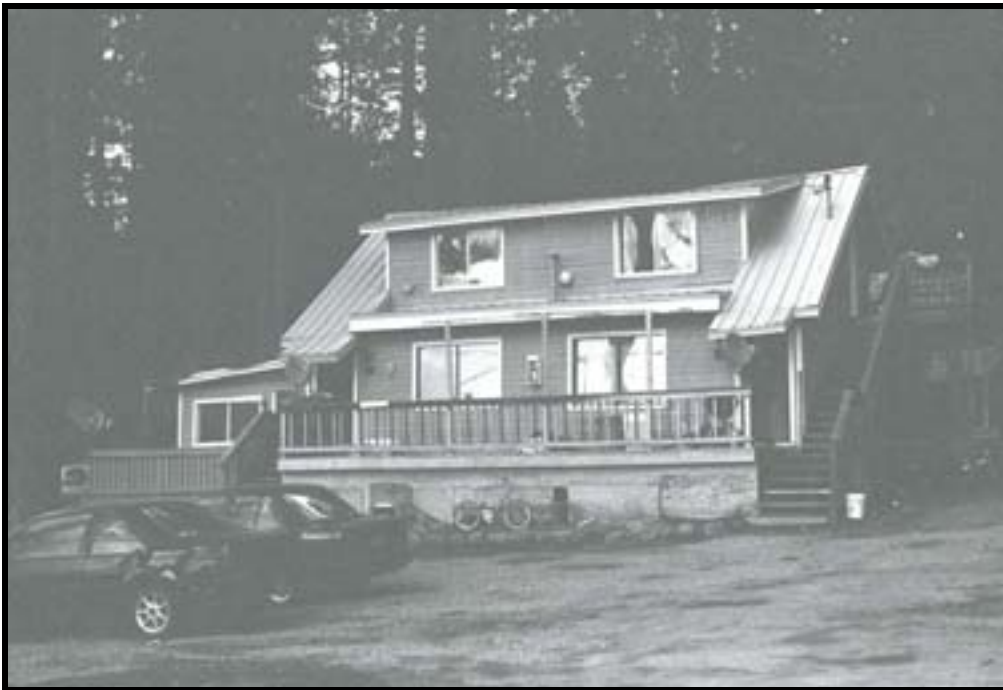
P5b. Description of Photo:
Front, facing NE.
KBB15 Fr.8, 4:10am

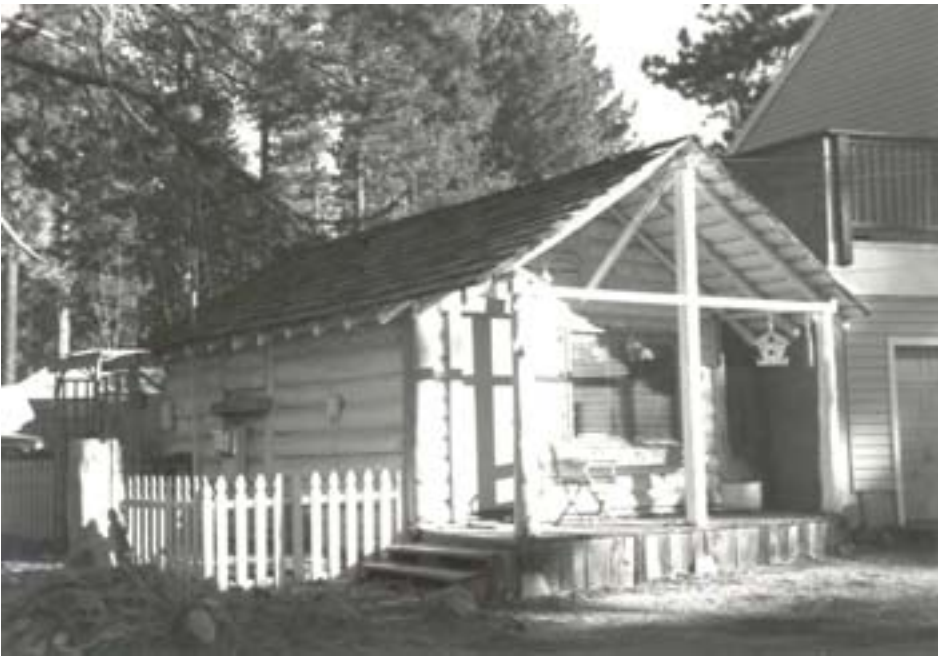
P5b. Description of Photo:
Back porch from Brockway Vista; View
NE; Roll KBB6, Fr.8,
01-13-03, 9:20 AM.

*B6. Construction History: Effective Year is 1924. The Year Built is not in the Assessor's database. The building is accurately portrayed on the 1936 highway construction map. One door has been blocked, but that modification is likely 1920s-1930s. The only recent (c.1990s) modification appears to be replacement of one window.

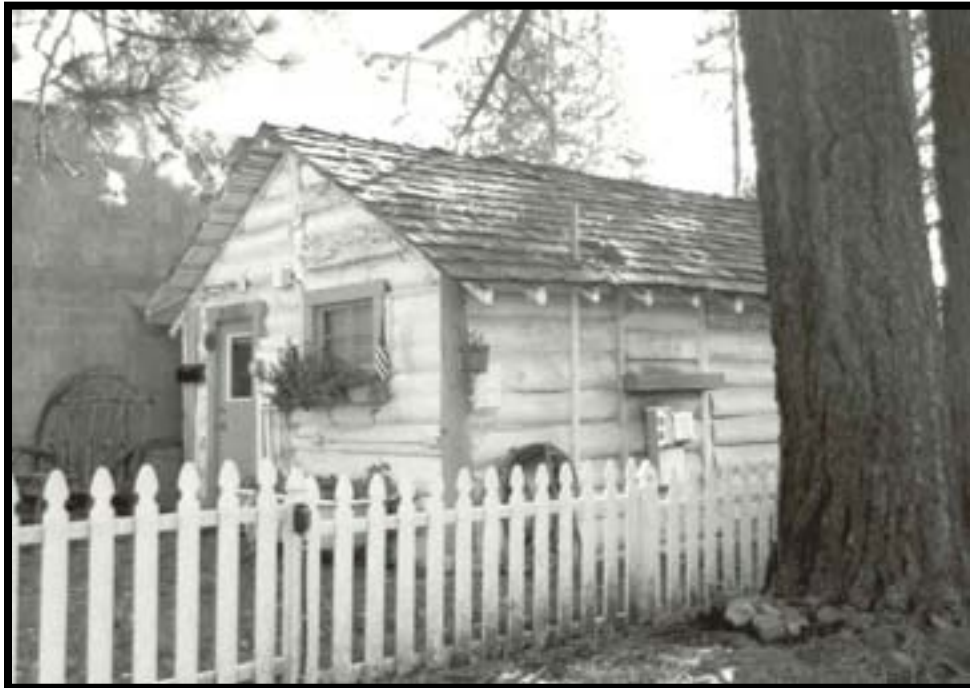
Front and west side from Secline Street, View SE;
Roll KBB3, Fr. 3, 11-14-02, 10:13 AM.

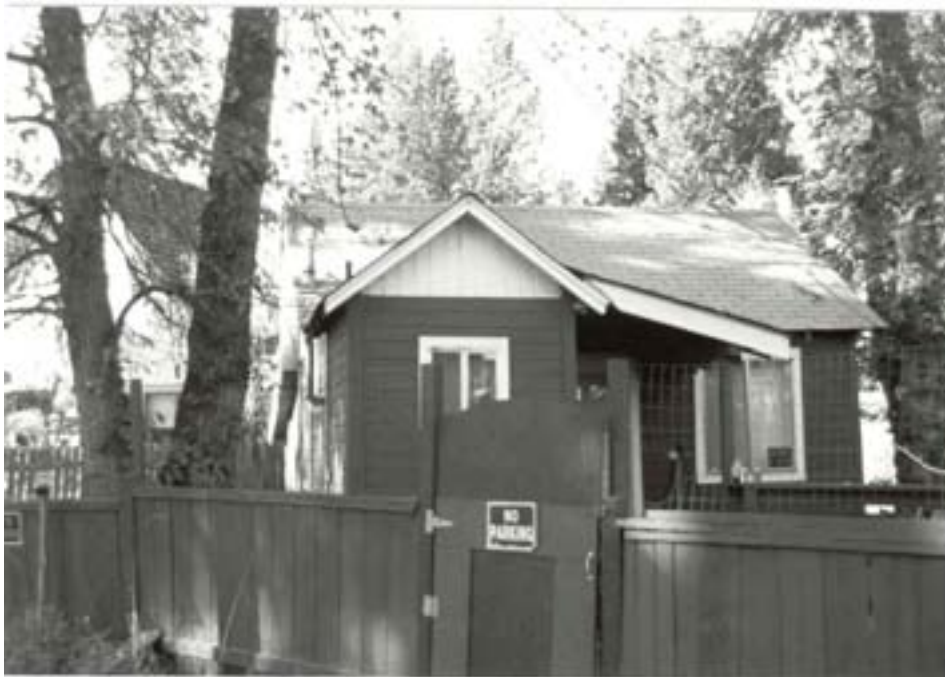
*P3a. Description: This building is a one-story L-plan wood frame house. It has a gable roof with exposed rafters and open eaves, clad with composition shingles. Walls are sheathed with painted wood V-rustic siding. The building has recent aluminum sliding windows and a wood one-light panel door. A recent shed roof has been installed over the entrance and a large dog door cut into the front door.

P5b. Description of Photo:
090-072-019, View NW.
Roll KBB2, Fr. 28. 10-31-02, 2:15 PM.

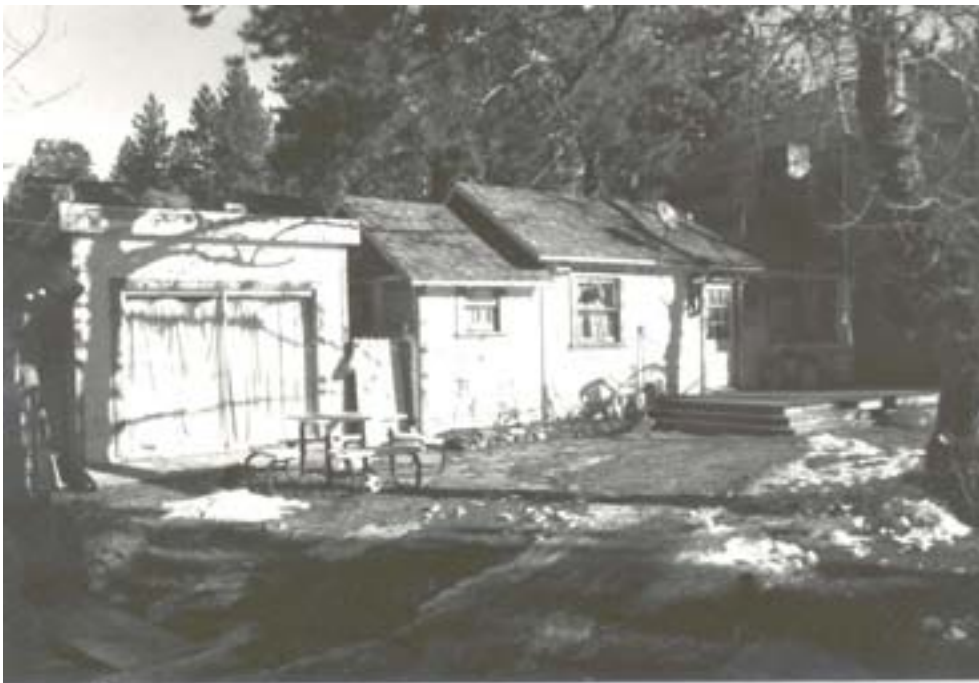
*P3a. Description: This building is a one-story rectangular plan wood frame house. It has a side-gable roof with open eaves and rafter ends partly obscured by a fascia, clad with composition shingles. Walls are sheathed with painted V-rustic wood siding. The building has wood 1/1 double-hung windows. The only modification is a recent wood X-panel door with nine lights. The building is set on a lot with a garage, lawn, native trees, and a recent deck.

090-072-016, View NE.

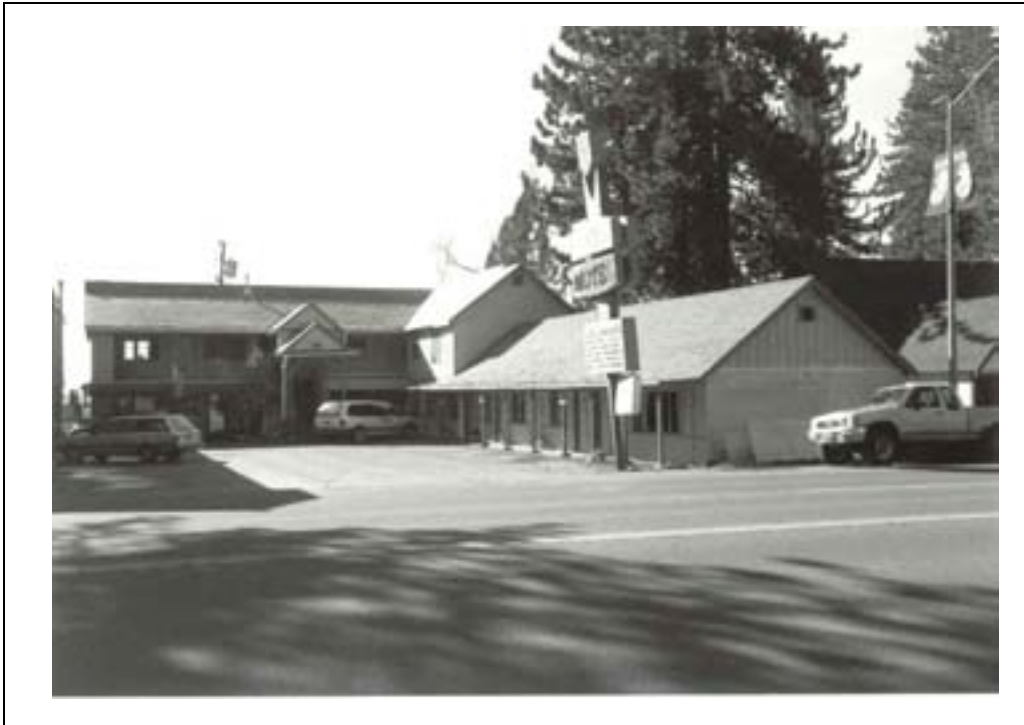
P5b. Description of Photo:
090-072-006, Overview from Hwy 28/
N. Lake Blvd, View S/SW.
Roll KBB3, Fr. 2, 11-14-02, 10:10 AM.

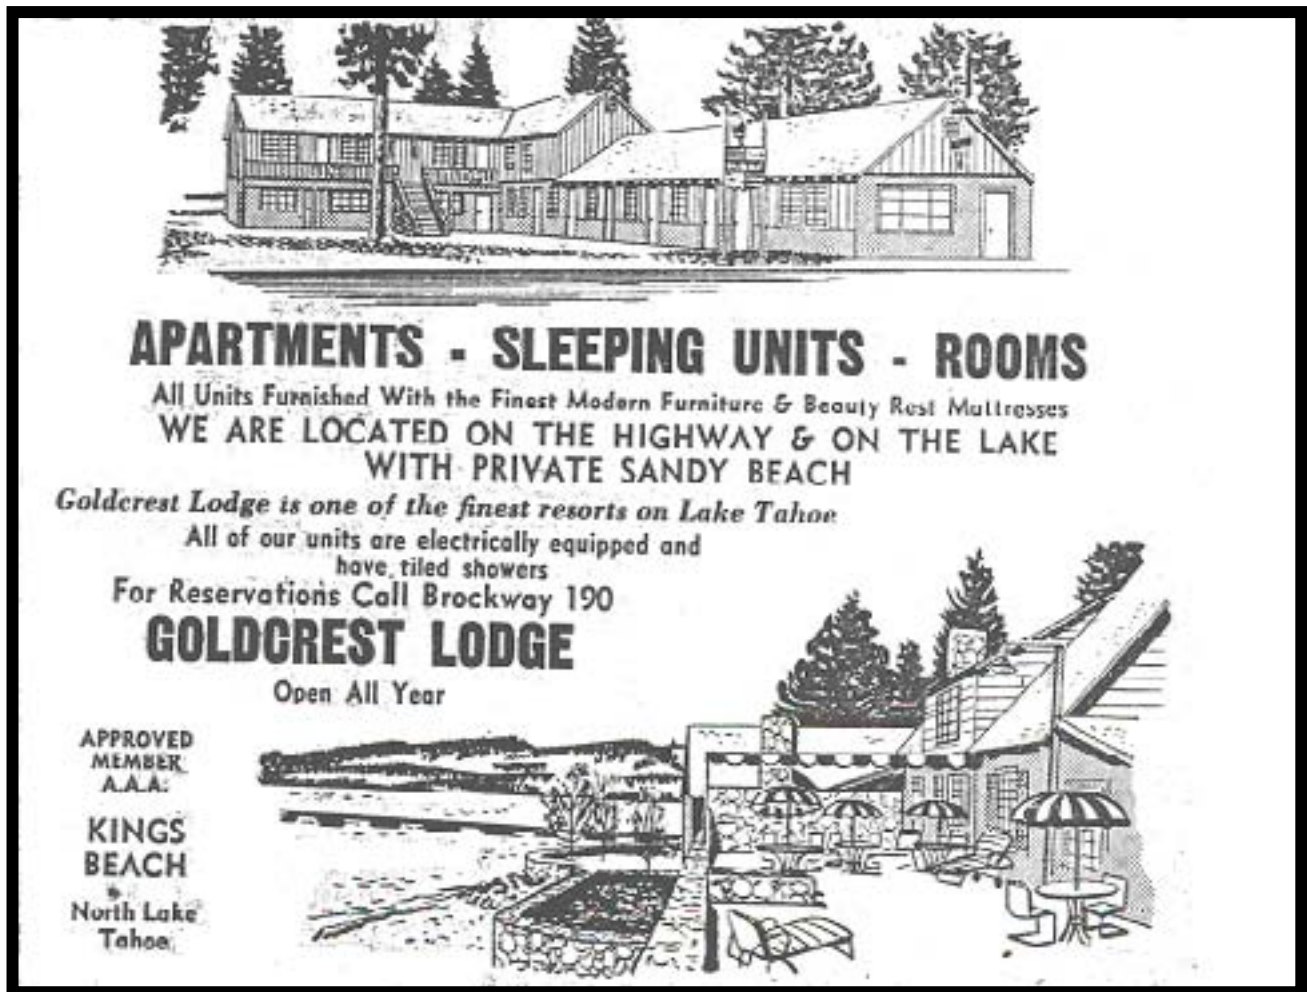
*B8. Related Features: Original sign (shown on attached ad) replaced with recent sign. Rest of historic complex is separated from this building by Brockway Vista Ave. and fronts the lakeshore, as shown in attached advertisement. This is outside of project area and not recorded or evaluated.

From 1952 Lake Tahoe Telephone Directory, Pacific Telephone and Telegraph Co. (Nevada Historical Society)
The image shows the portion of the complex outside the APE.

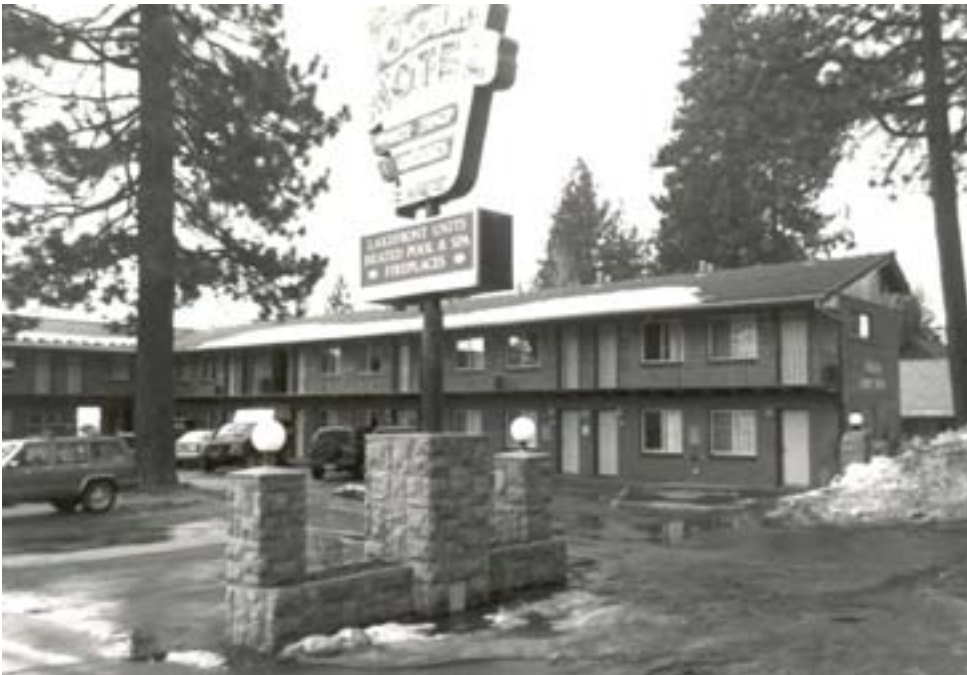
P5b. Description of Photo:
090-072-027, West wing, View SW.
Roll KBB6, Fr. 1. 01-13-03, 9:50 AM.

*B6. Construction History: Assessor's Year Built is 1955. The motel is shown on the 1956 CSAA map. Additions (c.1980s) may include much of second floor, rear, and entrance. Nearly all windows and doors appear to be recent (c.1990s) replacements.

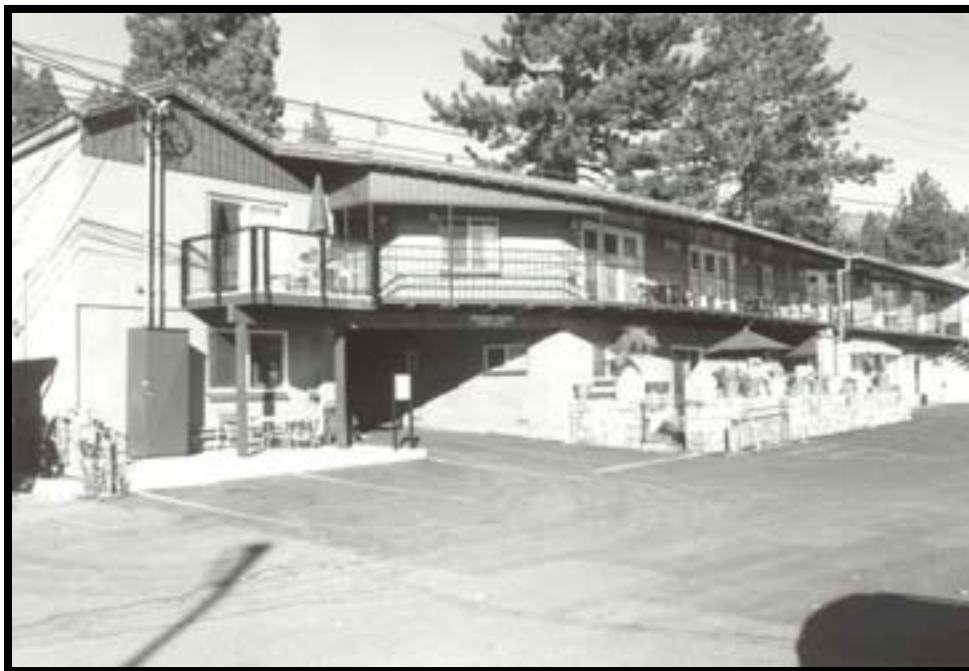
*B8. Related Features: Multi-colored stone wall around rear patio is similar to Stewart Indian School masonry found throughout the Tahoe Basin. An elaborate faux ashlar planter and light fixture forms the base of the sign on SR 28.

090-072-027 Rear, at Brockway Vista Ave., View NW.
Roll KBB2, Fr. 29. 10-31-02, 2:35 PM.

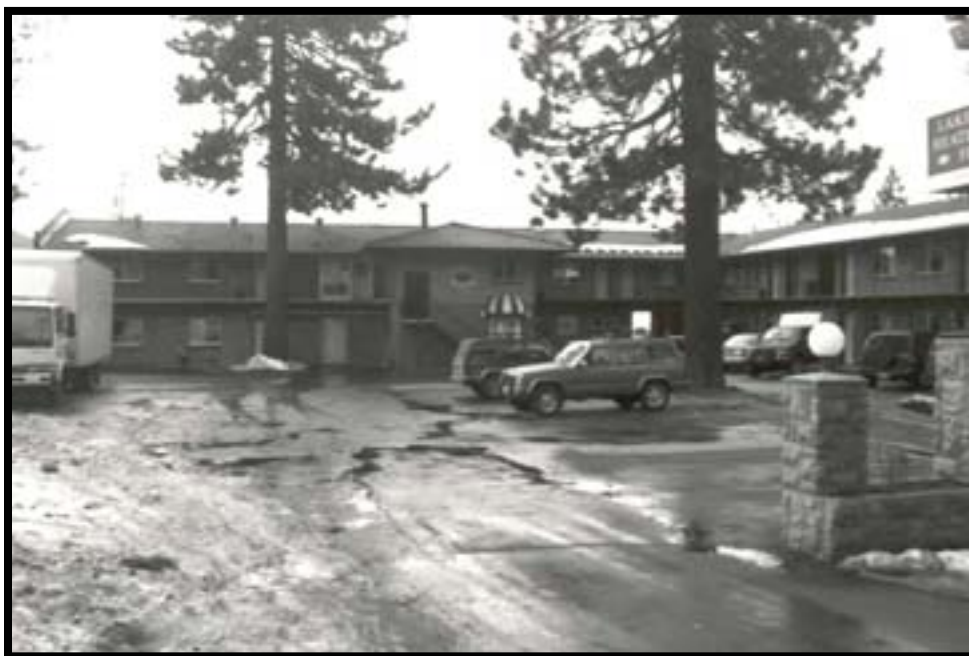
090-072-027 South wing, View S.
Roll KBB6, Fr. 2. 01-13-03, 9:51 AM.

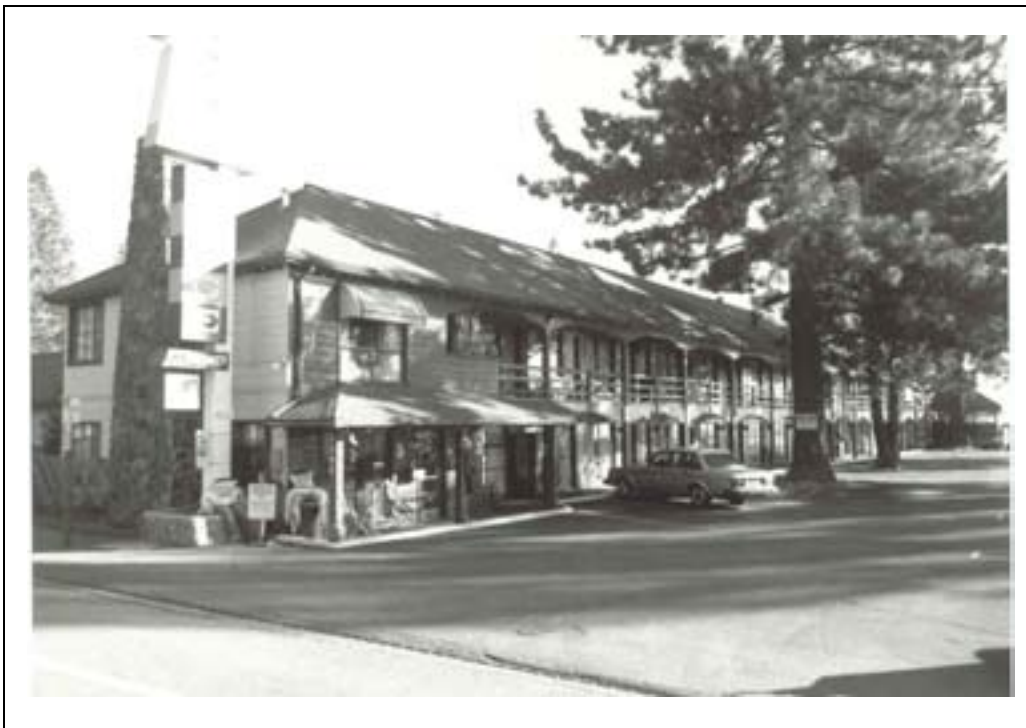
***P3a. Description:** This building is a two-story rectangular plan strip motel. It has a hip roof with open eaves and exposed rafter tails partly covered by a fascia, clad with composition shingles. Walls are sheathed with unpainted V-rustic siding. The building has a variety of fixed and casement windows, generally with six or eight lights. The office door has five lights, the rest of the doors are flush. As comparison of the attached historic advertisement and recent photo shows, the building is almost unmodified. The largest addition is a gazebo at the rear of the building. The historic sign has been replaced and a canopy placed over one window.

090-072-026, View SE.

*B6. Construction History: Assessor's Year Built: 1952, confirmed by first appearance in phone books in 1953. Owner-managers noted in 1955-56 phone books are Marcia and Malin Petz. Modifications include a c.1990s gazebo, sign, and canopy over one window.

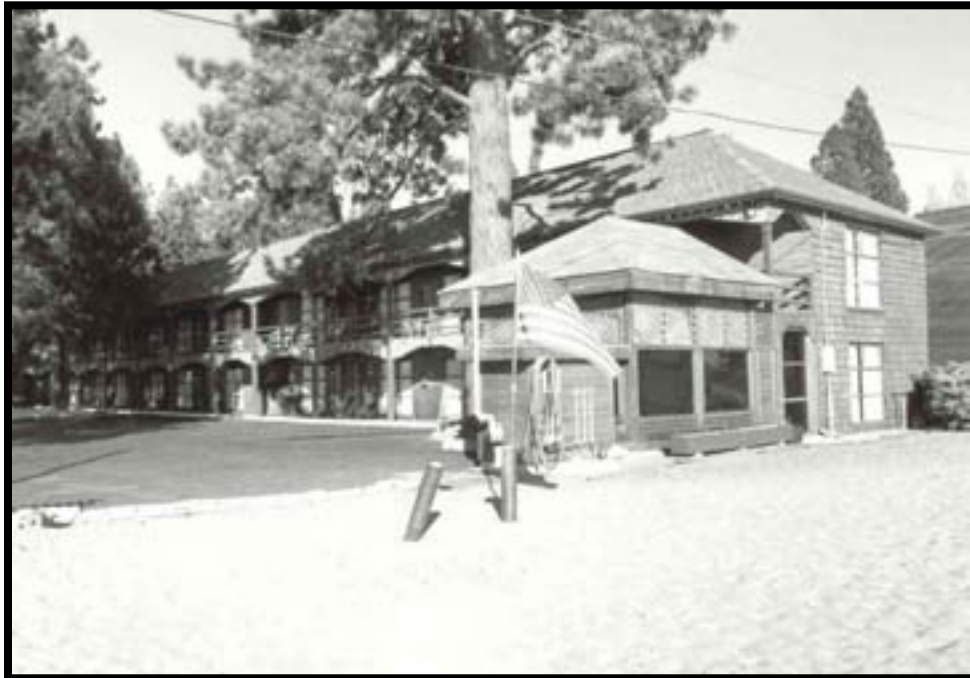
090-072-026 Rear at Beach, Gazebo in foreground. View NE. Roll KBB2, Fr. 32, 10-31-02, 2:47 PM.
